GIAC Advance Incident Handling and Hacker Exploits Track

*Practical for Option 1 - Illustrate
an Incident*

This practical concerns an incident that occurred on August 4, 2000 at the Network Operations Center (NOC) of Federal Computer Systems Incorporated (FCSI). On that date, a sprinkler system head exploded during a furniture and equipment move within the FCSI NOC. This event caused concern as the FCSI NOC was a production environment. From the NOC, FCSI remotely and securely manages client networks and infrastructures. They provide "near-real-time" reporting and correction of network faults and outages. Any interruption of the NOC infrastructure would cause a loss of revenue for FCSI.

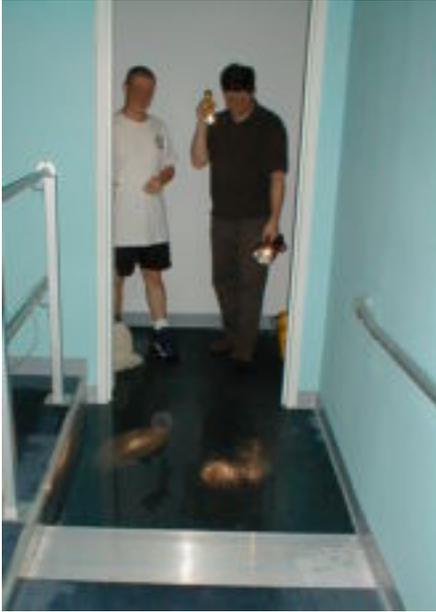
FCSI employees survey the water on the NOC entryway floor.

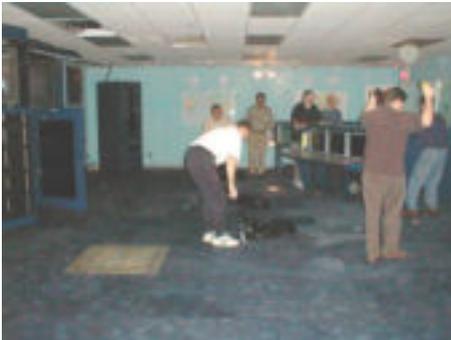
Clean up efforts are underway inside the FCSI NOC.

As soon as the fire department had left and the "all clear" signal was given that allowed employees back into the facility, MW, the Senior Vice President, organized a basic cleanup effort. He began by sending some individuals to a local home-improvement store for mops and buckets in an effort to remove the standing water in the NOC. Additionally, he gathered a group of employees to begin removing the remaining furniture from the NOC. VS, the Executive Administrative Assistant, called a company that specializes in the restoration of spaces that have suffered fire or water damage. They arrived one-and-a-half hours later.

The recovery process continued for several days. The professional recovery firm removed the remaining standing water. The FCSI NOC staff, led by DR, repainted the NOC and eventually reconfigured the furniture. A carpet company was brought in to remove the existing water-soaked carpet and lay new carpet down.

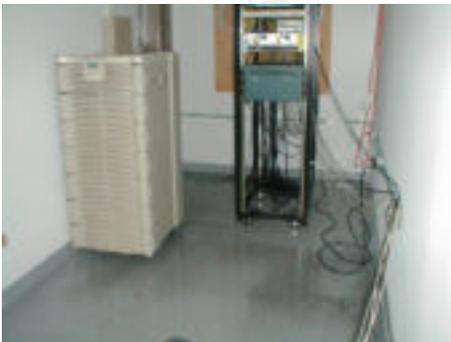
More water damage in the server storage space.
