GCIH PRACTICAL ASSIGNMENT

Phone Phreaking and Social Engineering

Submitted by Richard Tuey

Date Submitted: January 29, 2002

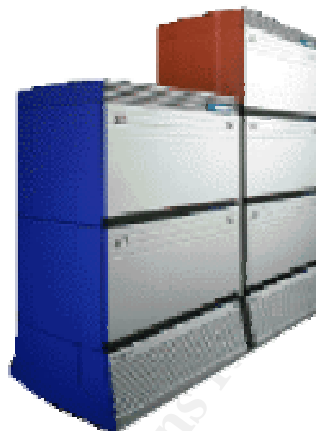
Telecom (Nortel) Meridian 1 Option 61C PBX/VMS. The Meridian 1 serves up to 2000 ports. The operating system uses dual Motorola processors.

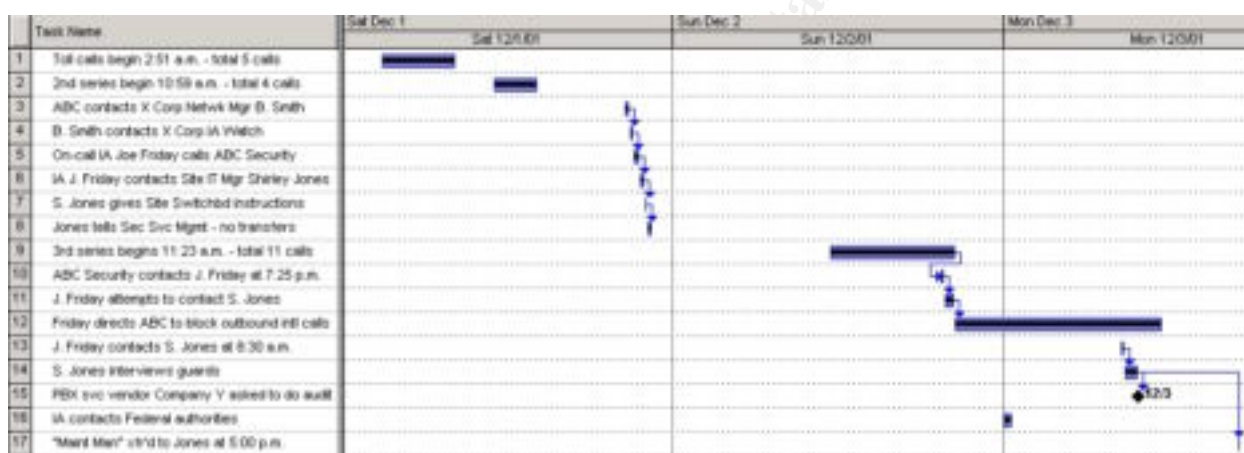
The timeline of key events appears below:
